Performance Testing Guide

Vulcan Timber

A Trusted Choice in High Performing Modified Timber

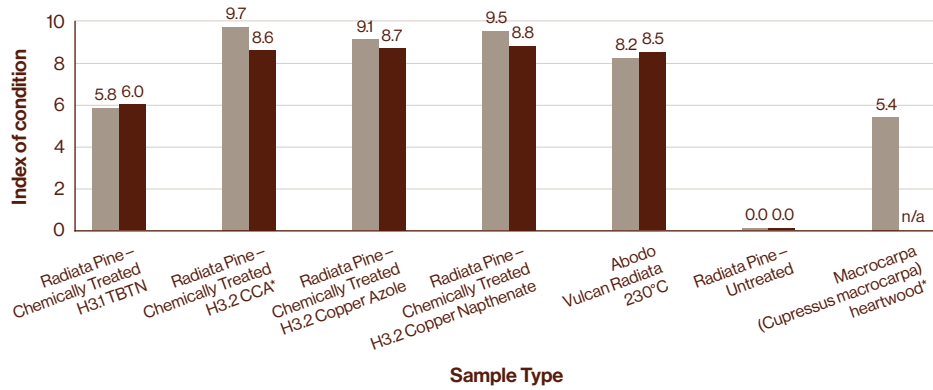
Graph 1: Decking Panels - Condition After 11 Years

Samples were installed horizontally onto bearers with one end fixed to an untreated radiata pine bearer and the other end fixed to CCA treated bearer.

Key: ■ Treated Bearer ■ Untreated Bearer

*Samples assessed after 13 years.

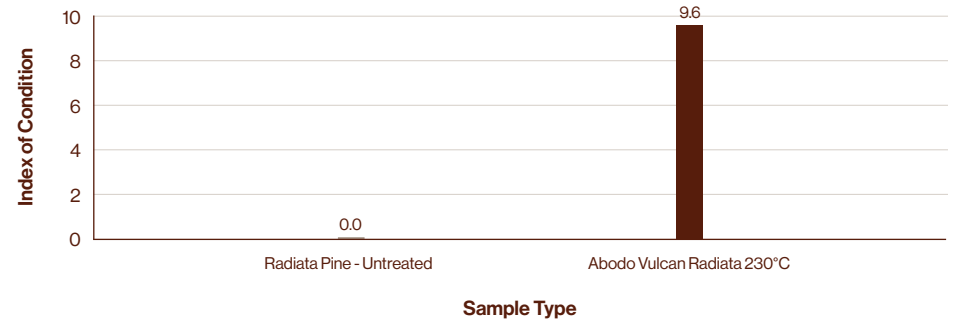
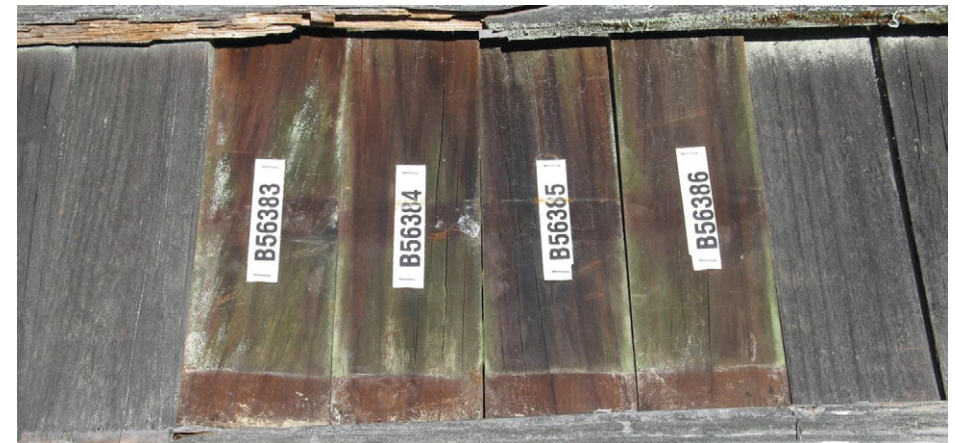
Graph 2: Flat Panels – Condition After 11 Years

Samples were installed onto racks at a 45° angle with one end resting on an untreated radiata pine bearer.

Flat panels Vulcan Radiata 230°C after 11 years exposure, Rotorua.

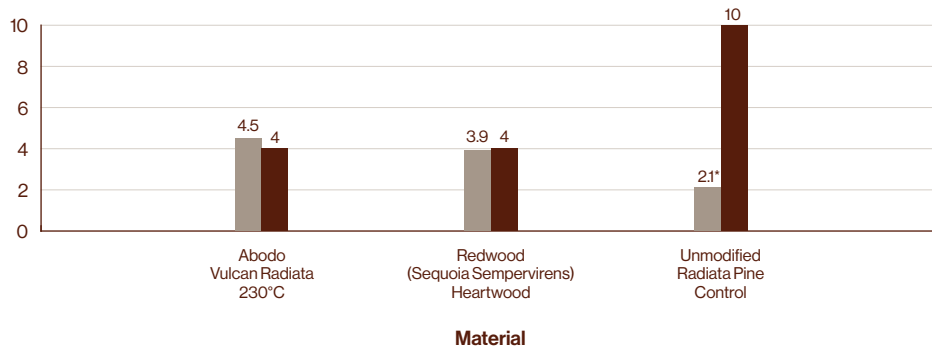
Graph 3: Condition of Stakes After 5 Years

20mm x 20mm stakes were installed in ground contact and the condition was assessed by Scion Research after 5 years.

Key: ■ Index of Condition ■ Number Failed

*Average life 2.1 years.

CONCLUSION: While thermally modified wood is most suited to above ground applications, this test suggests performance similar to redwood.

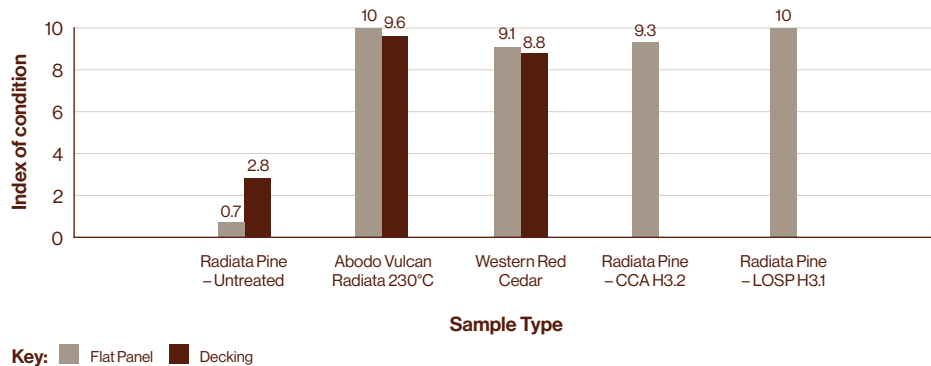
Graph 4: Flat Panel and Decking – Condition of Samples After 6 Years

Vulcan thermally modified timber samples were installed in flat panel and decking configurations according to Australasian Wood Preservations Committee (AWPC) protocols. Flat panel samples were installed onto racks at a 45° angle with one end resting on an untreated radiata pine bearer. Decking samples were installed horizontally onto bearers with one end fixed an untreated radiata pine bearer and the other end fixed to CCA treated bearer.

CONCLUSION: After 6 years the Vulcan Radiata 230°C is performing better than old growth western red cedar and similarly to chemically treated radiata pine.

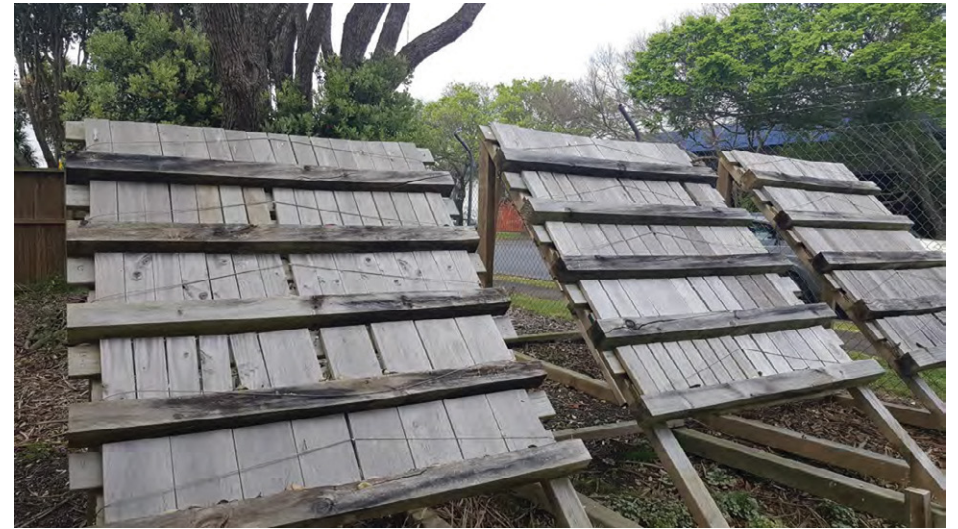
Flat panel test racks, Mangere.

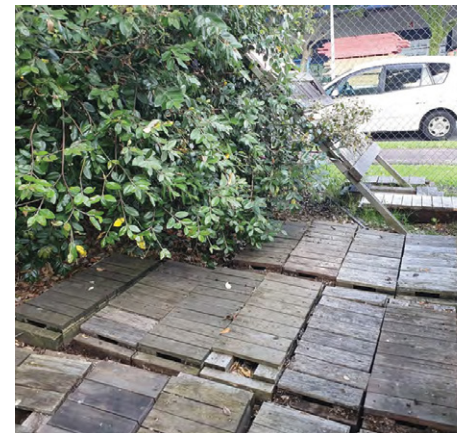
Decking test panels, Mangere.

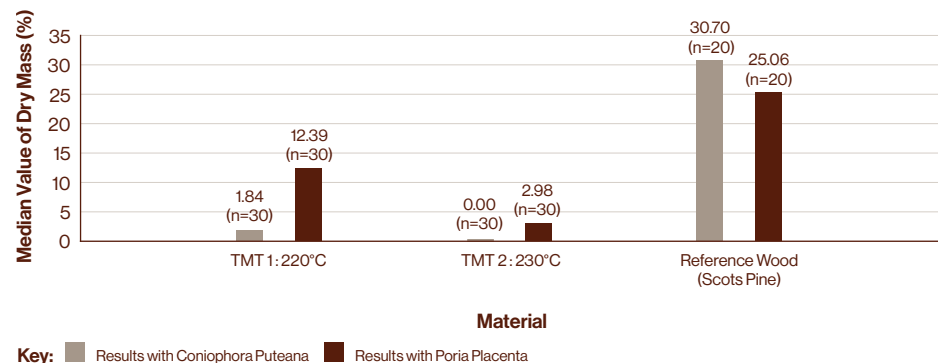
Graph 5: Mass Losses and Corresponding Durability Classes of Thermally Modified Radiata Pine

A durability test of thermally modified radiata pine against a laboratory test against wood decay basidiomycetes according to the laboratory test DIN CEN/TS 15083 1:2005.

RESULT: Evaluation according to EN350-1 is Durability Class 1.

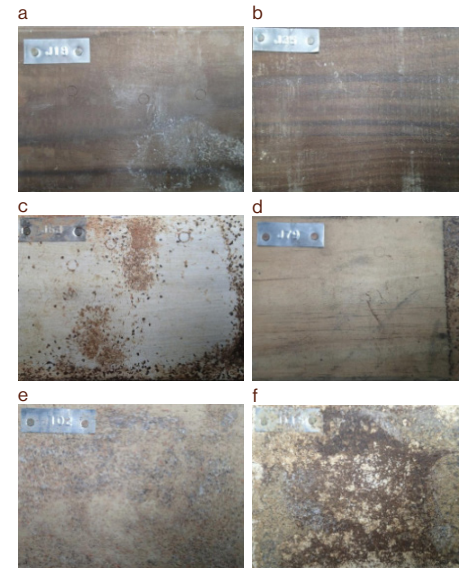
Example of termite attack to treated test specimens after exposure to *C. acinaciformis* in a Hazard Class H3 field trial for 38 weeks: a) Vulcan Radiata 230°C TPX uncoated, b) Vulcan Radiata 230°C TPX stained, c) Vulcan Radiata 230°C TPX painted, d) radiata pine, uncoated, e) radiata pine TPX, uncoated, LOSP, and f) radiata pine, painted, LOSP.

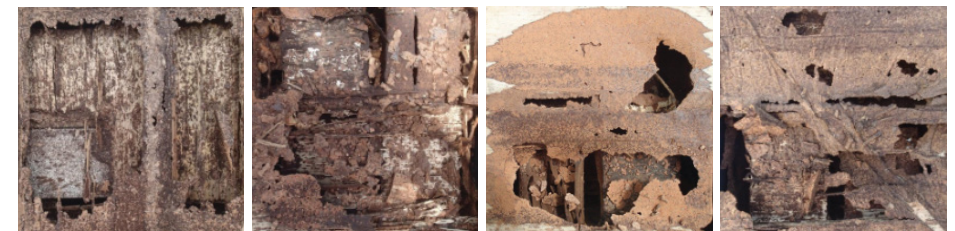
Example of attack by *C. acinaciformis* termites to bait-wood after 38 weeks' exposure in a Hazard Class H3 field trial.

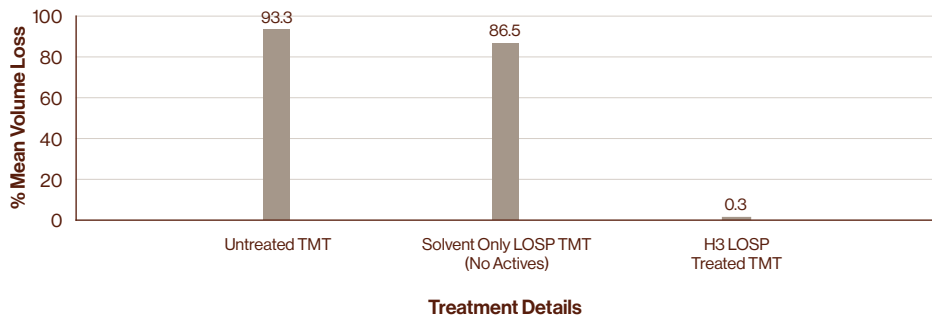
Graph 6: Treatment Volume Loss

Azole and permethrin treated Abodo Vulcan Radiata 230°C was exposed for a period of approximately 6 months to *Coptotermes acinaciformis* termites in Northern Queensland, Australia following the Brick-assembly technique described by the Australasian Wood Preservations Committee (AWPC).

70 x 30 mm cross section Abodo Vulcan Radiata 230°C was LOSP treated with preservative actives targeting the minimum AS/NZS 1604.1:2021 retention of 0.02% permethrin for H3 treated timber (plus azoles for decay control). These actives are the same type and retention as used in Abodo OPX treatment.

A leaching step was performed consisting of 7 days in a 35°C shaking water bath with the water replaced 5 times. All treatments were kept separate. Finally, all samples were vacuum dried at 40°C and -95 kPa for 5 days.

CONCLUSION: The AWPC protocols allow a maximum of 5% volume loss for any treatment before it has deemed to have failed the test. In this trial, the treated samples had less than 5% volume loss so is deemed to be efficacious.

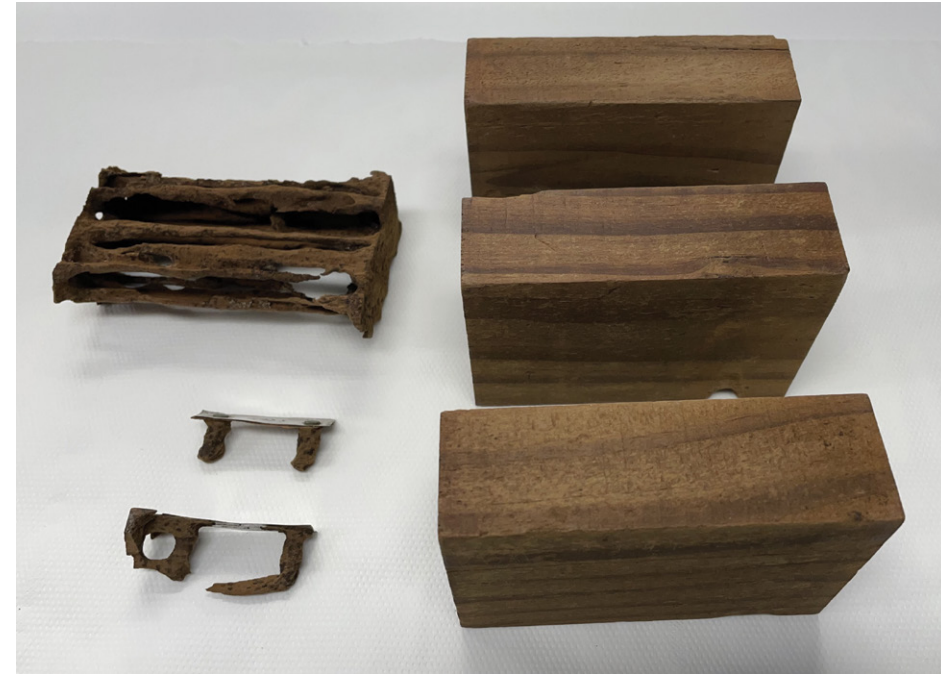
Comparative performance of Vulcan Radiata 230°C untreated (left) vs LOSP Azole and permethrin treated (right), when exposed to *Coptotermes acinaciformis* termites in AWPC H3 field test, Queensland.

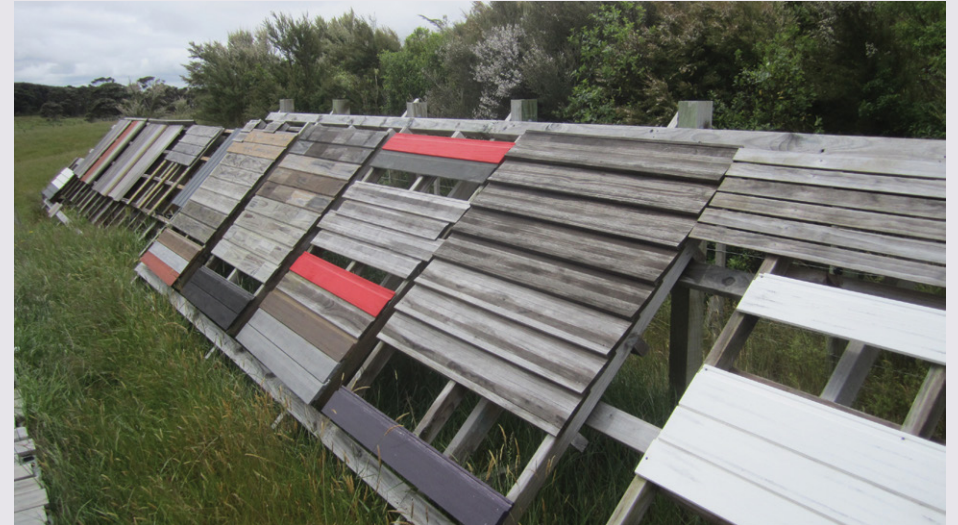
Flat panel test racks, Mangere.

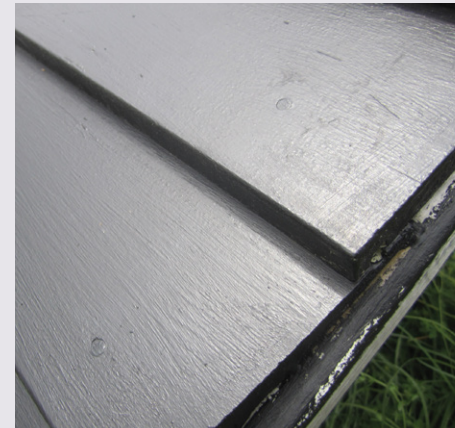
Vulcan – Painted black, 3 years exposure.

RESULT: After three years exposure the paint finish on the Vulcan cladding was in excellent condition with no failure. The paint finish on the radiata pine cladding had failed, with extensive flaking and cracking present due to the movement of the timber substrate.

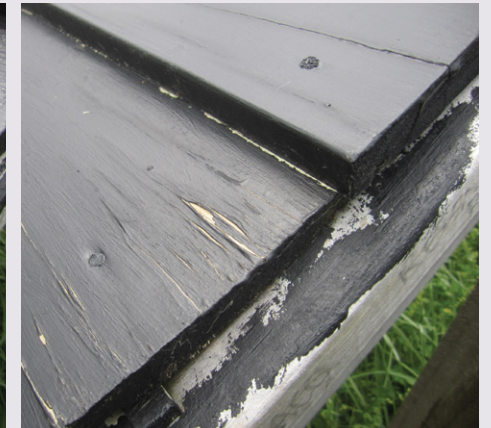
MCA Treated KD Radiata Pine, 3 years exposure.

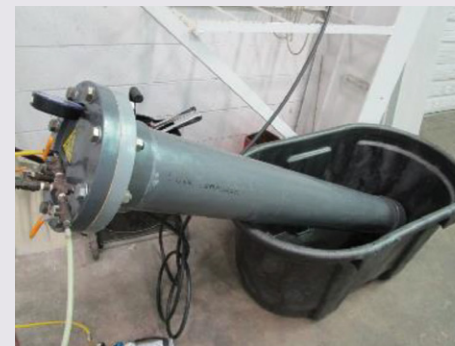
Intertek, USA conducted delamination testing on Vulcan laminated timber according to ASTM D5824. This method includes submersion in water with vacuum and pressure soak 30 minutes respectively prior to testing.

Testing in-progress detail.

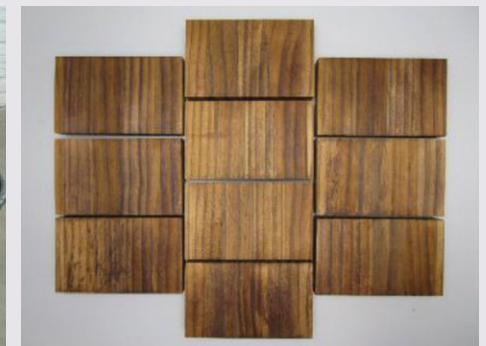
Post-test specimen detail.

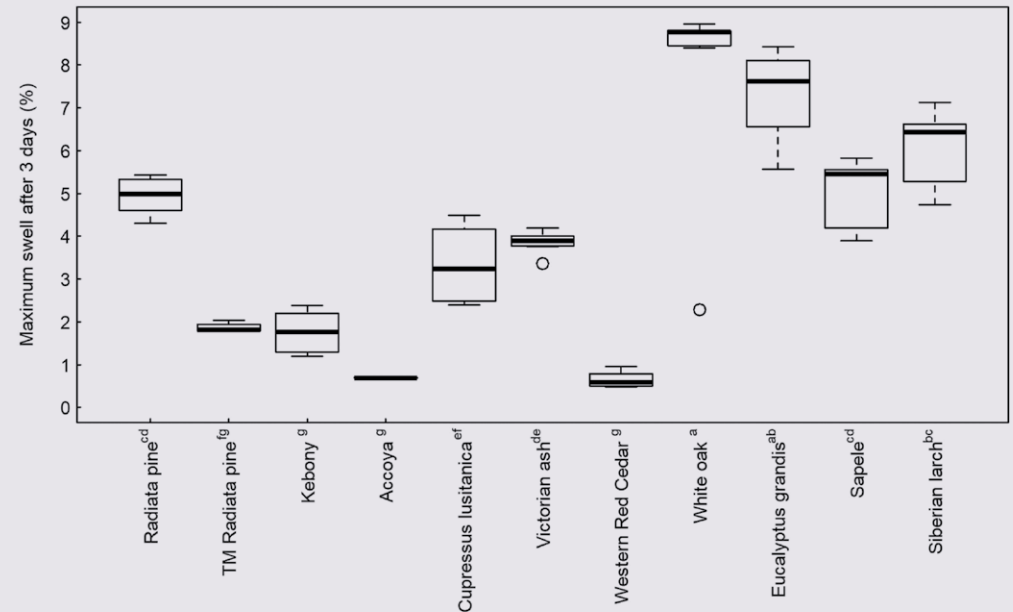
Wood samples were equilibrated at 25°C, 65% RH and then soaked in water for three days and continuously measuring the change in tangential dimension during soaking.

FIGURE 1. Maximum swelling following 3 days water soaking in the Swellometer test. Superscript letters indicate grouping that are not significantly different (95% confidence level).

Under conditions of both water soaking and air humidity changes, Vulcan Radiata 230°C was significantly more dimensionally stable than unmodified radiata pine, and it performed similarly to Western Red Cedar, a species renowned for its dimensional stability.

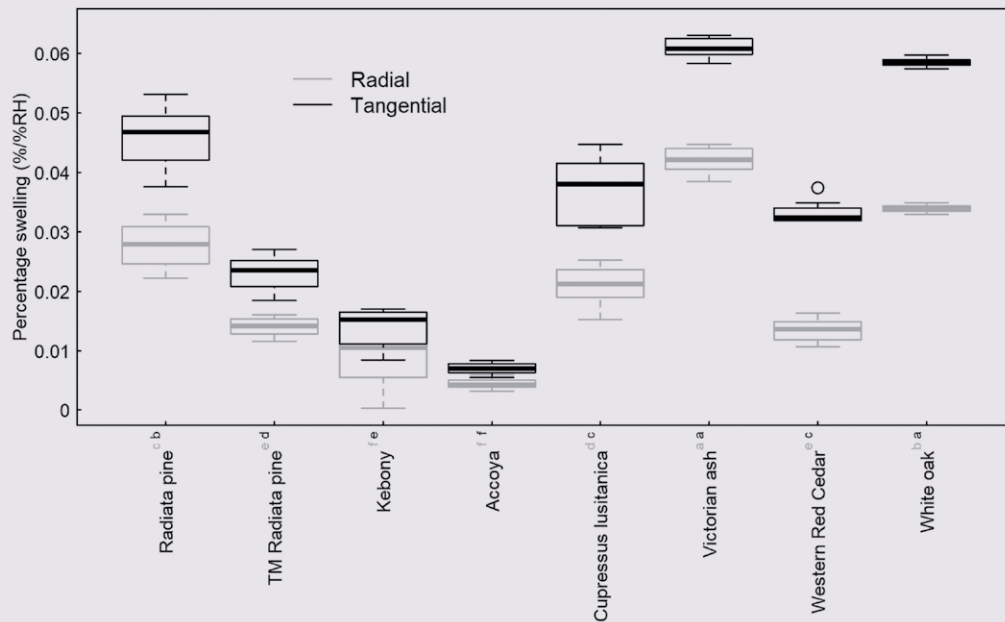
Wood samples were equilibrated to several environments ranging from low to high relative humidity and measuring the radial and tangential dimensions of the samples at each condition.

FIGURE 2. Percentage swelling for every 1% change in relative humidity for each wood type in the tangential and radial directions (shown as black and grey boxes respectively). Superscript letters indicate grouping that are not significantly different (95% confidence level).

Kebony and Accoya radiata pine were more dimensionally stable than thermally modified radiata pine in relation to changes in air humidity, while when soaked in water the levels of swelling were not significantly different to thermally modified radiata pine.

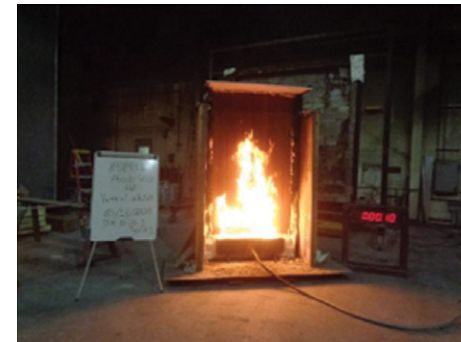
Test facility: Intertek, USA.
Testing in accordance with SFM 12-7A-1.

Test Requirement	Result
Absence of flame penetration through the wall assembly	PASS
Absence of glowing combustion on the interior of the assembly after 70 minutes	PASS

WUI test.

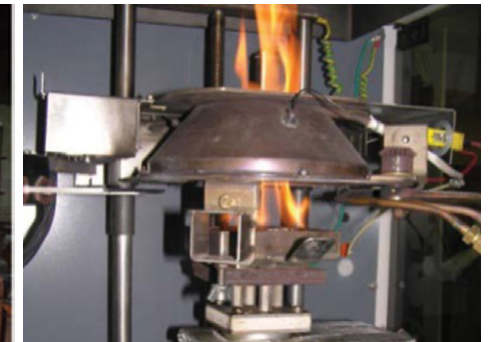
Test facility: BRANZ, New Zealand.
Testing in accordance with AS/NZS3837:1998 and ISO5660-1.
Classification according to NZBC C/VM2 Appendix A and AS5637.1:2015: **Group 3**.

ISO5660 Cone test.

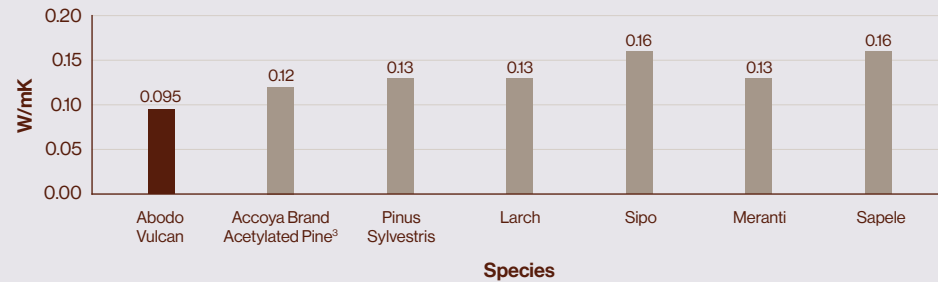
Graph 7: Comparative Thermal Performance of Various Common Joinery Timbers

Abodo has created Vulcan modified wood with extremely low thermal conductivity even when compared with other timber products. Performance is up to 30% better than softwood and up to 60% better than hardwood.

Test Method	Average Thickness (mm)	Average Temperature (°C)	Thermal Conductivity (W/mK)	R-value (m²K/W)
EN12667	42.55	10	0.095	0.4474

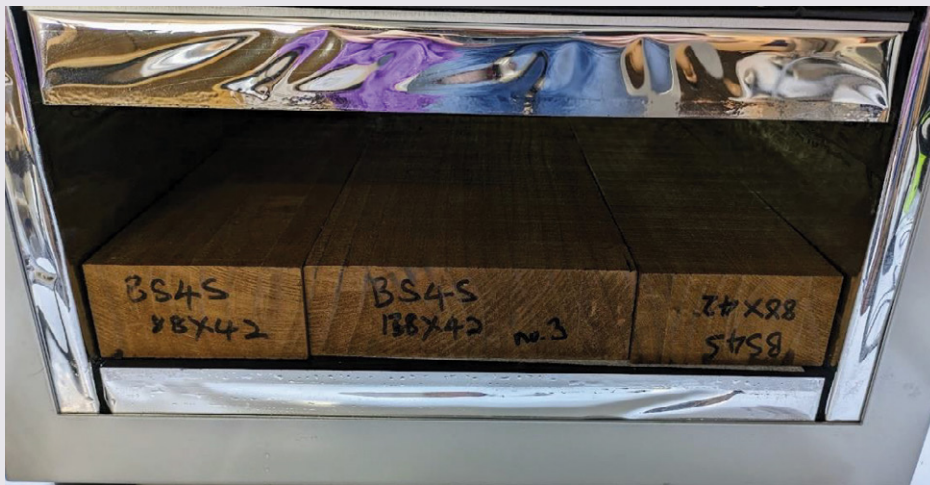
Testing was conducted by Thermtest, Sweden according to ASTM C518, ISO 8301, and EN 12667 standards.

Sample configuration set up.
